**GREATER
MANCHESTER**
FIRE AND RESCUE SERVICE

The Cube

Incident Report and Key Observations
regarding the fire which occurred on

15 November 2019

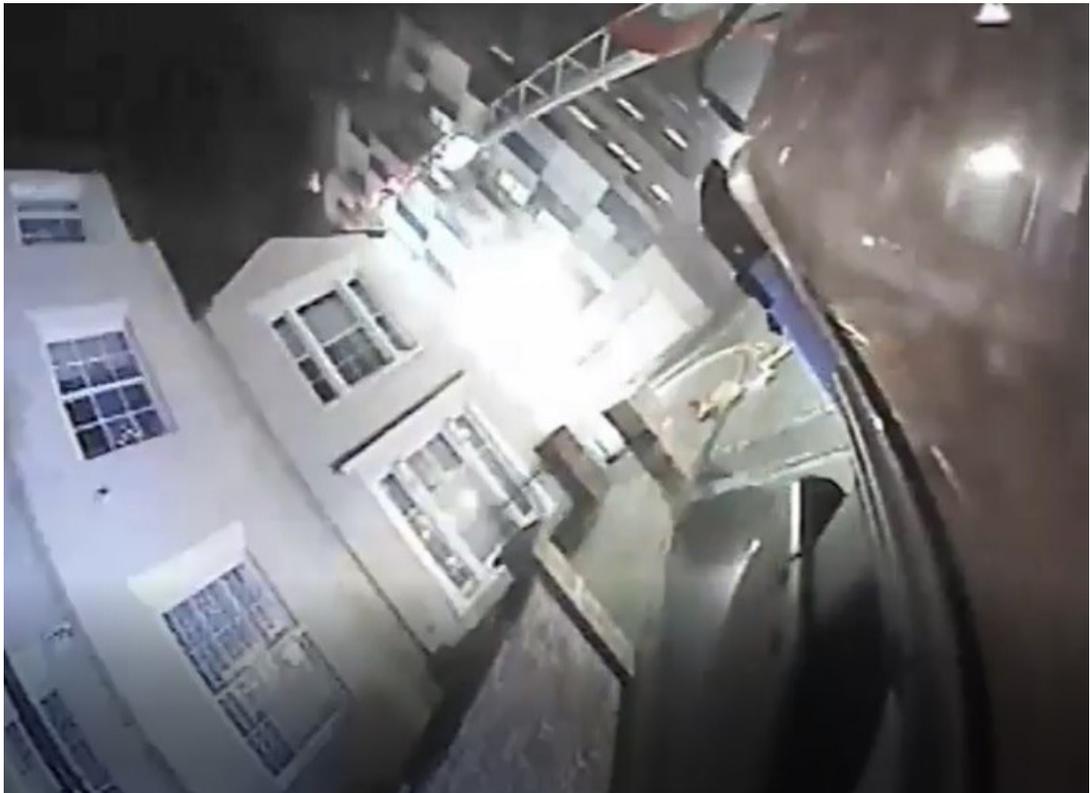
Image 5: Appliance CCTV (TTL) showing 32 metre ladder extended to sixth floor of The Cube to effect a rescue

Following the rescue from the sixth floor another occupier was reported and located by crews by a window at the rear of the building on the second floor. The resident was subsequently rescued by crews using a short extension ladder.

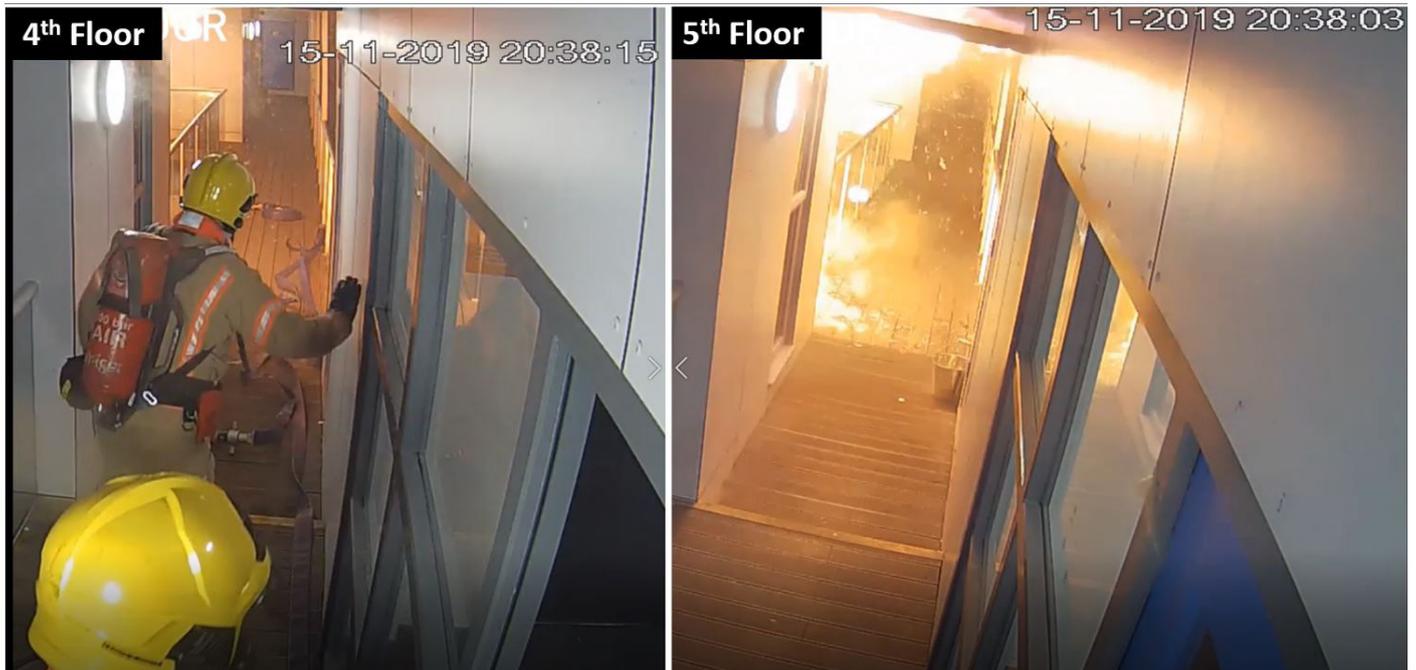
Image 8: Internal CCTV 20:38hrs – 15th November 2019

- 95.** The simultaneous images below were captured on The Cube's CCTV, showing fire development on the fifth and fourth floors at 20:38 hours, 10 minutes after the first 999 call.

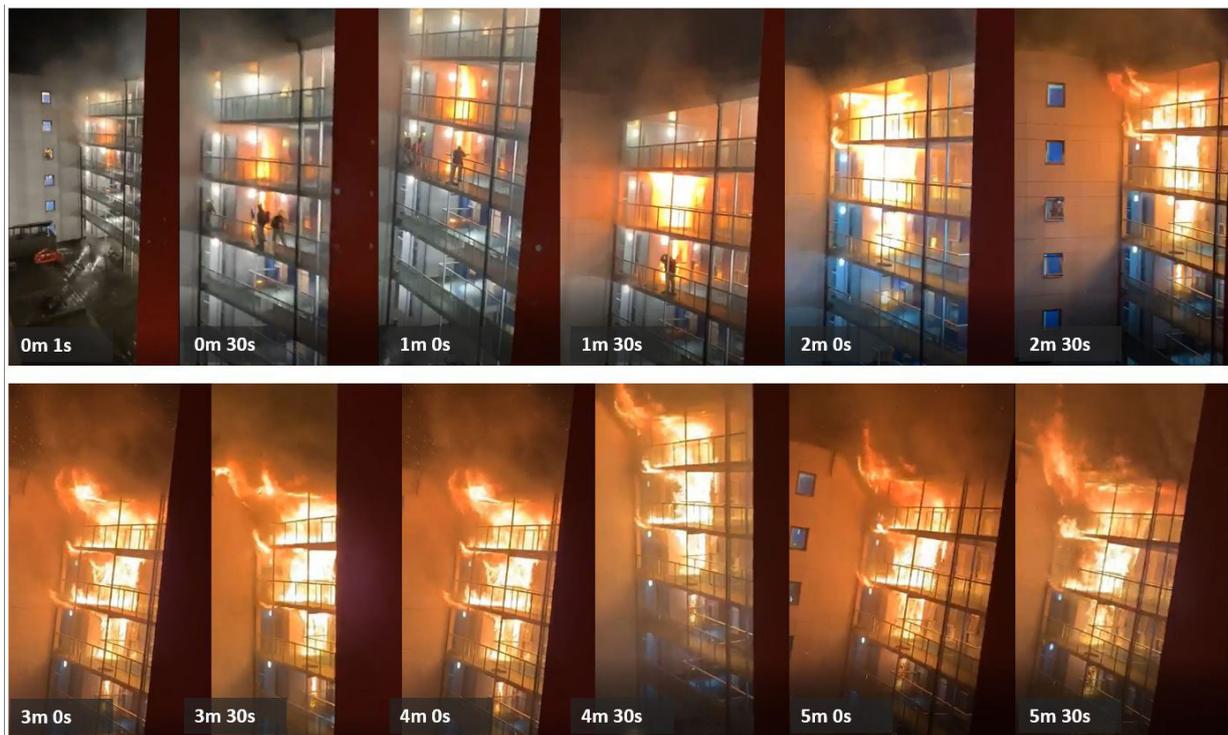
Image 8: The Cube - collation of still images taken from video footage recorded within 10 minutes of initial 999 call - 15th November, 2019

148. Firefighters attending the scene were faced with rapidly developing and unpredictable fire spread. Burning debris falling from the sixth floor, collected within the recessed façade of the building at ground level, developing further seats of fire. This was particularly noticeable in the atrium area between the north stairwell and the accommodation. The fire then spread upwards, causing large amounts of radiant heat from roof level.

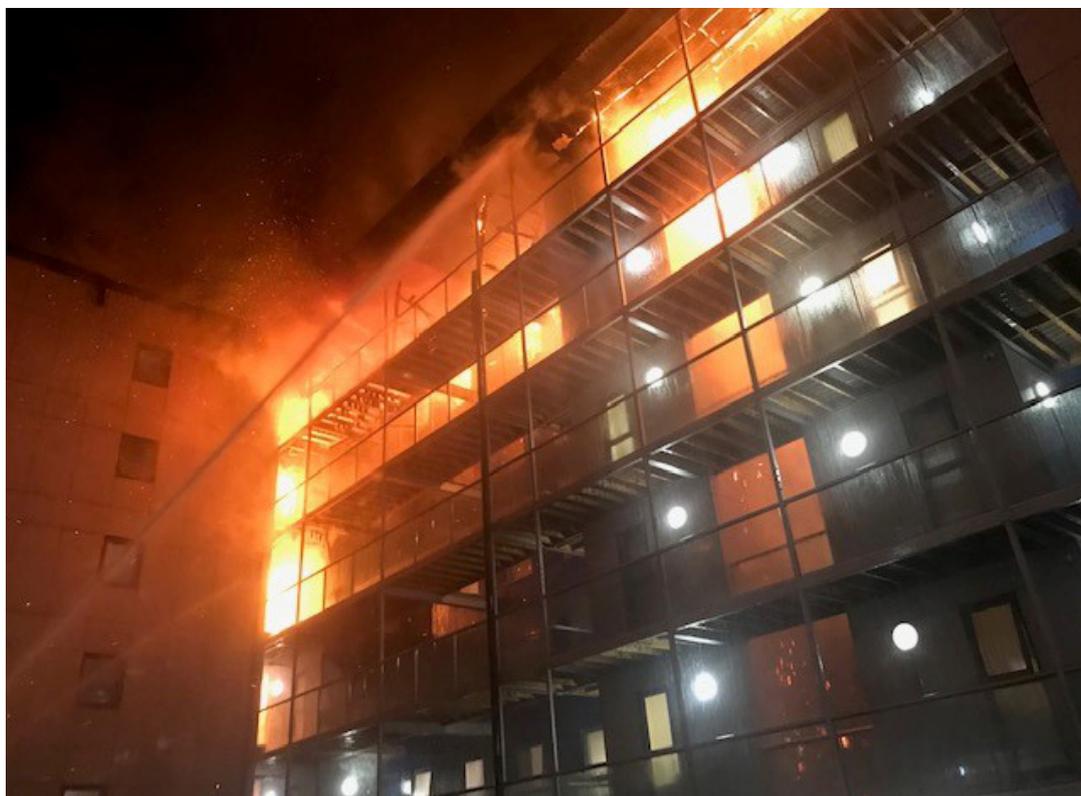
Image 9: The Cube – Phase 2 – 15th November 2019

- 152.** Below level six, the internal compartmentation appeared to be largely effective in checking the spread of fire. Level six, however, was fully engulfed in flames and completely destroyed.
