Pyroguard Balustrades Guidance

Behaviour in the event of breakage...

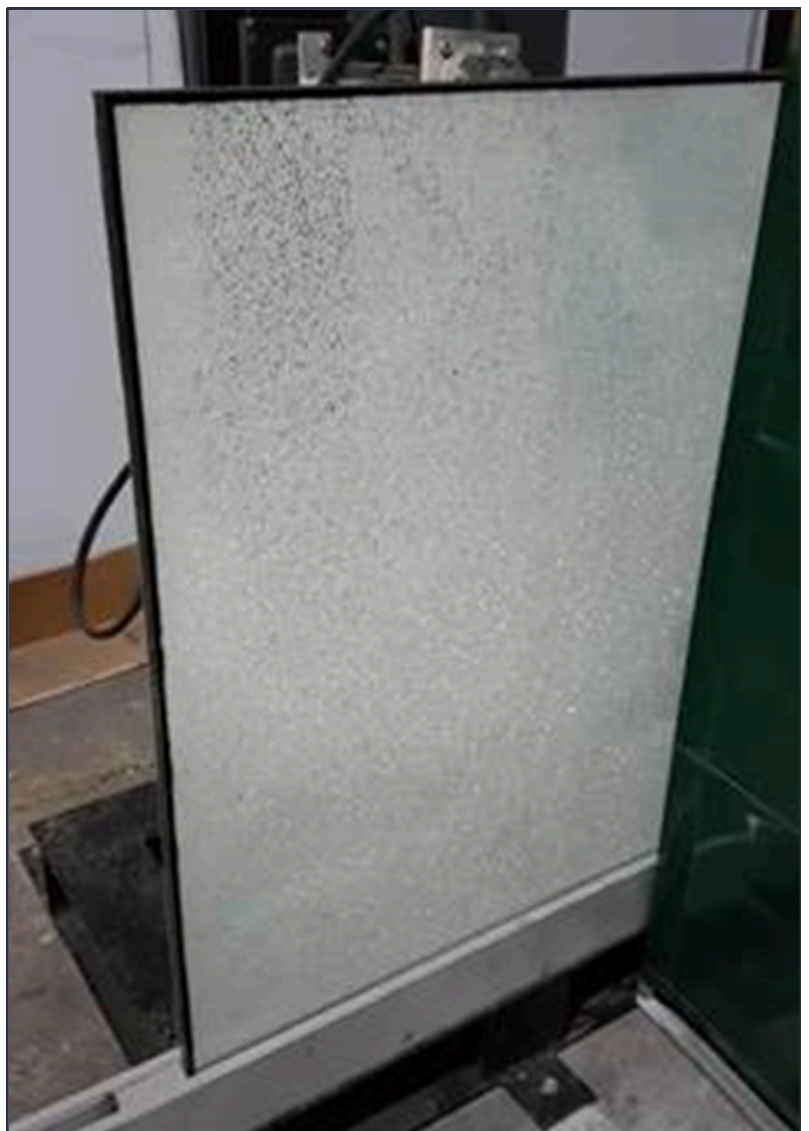
Figure 1 Example test result for Pyroguard Balustrades

Pyroguard can confirm that in the event of one of the toughened glasses breaking in the fire-resistant glass balustrade panel, the fragments of glass will stay adhered to the interlayer and will not fall off. This can be seen clearly in Figure 1. However, the panel should still be replaced immediately.

Under normal circumstances the unit itself will maintain rigidity, such that it will not collapse out of the balustrade construction under its own weight.
