**GREATER
MANCHESTER**
FIRE AND RESCUE SERVICE

The Cube

Incident Report and Key Observations
regarding the fire which occurred on

15 November 2019

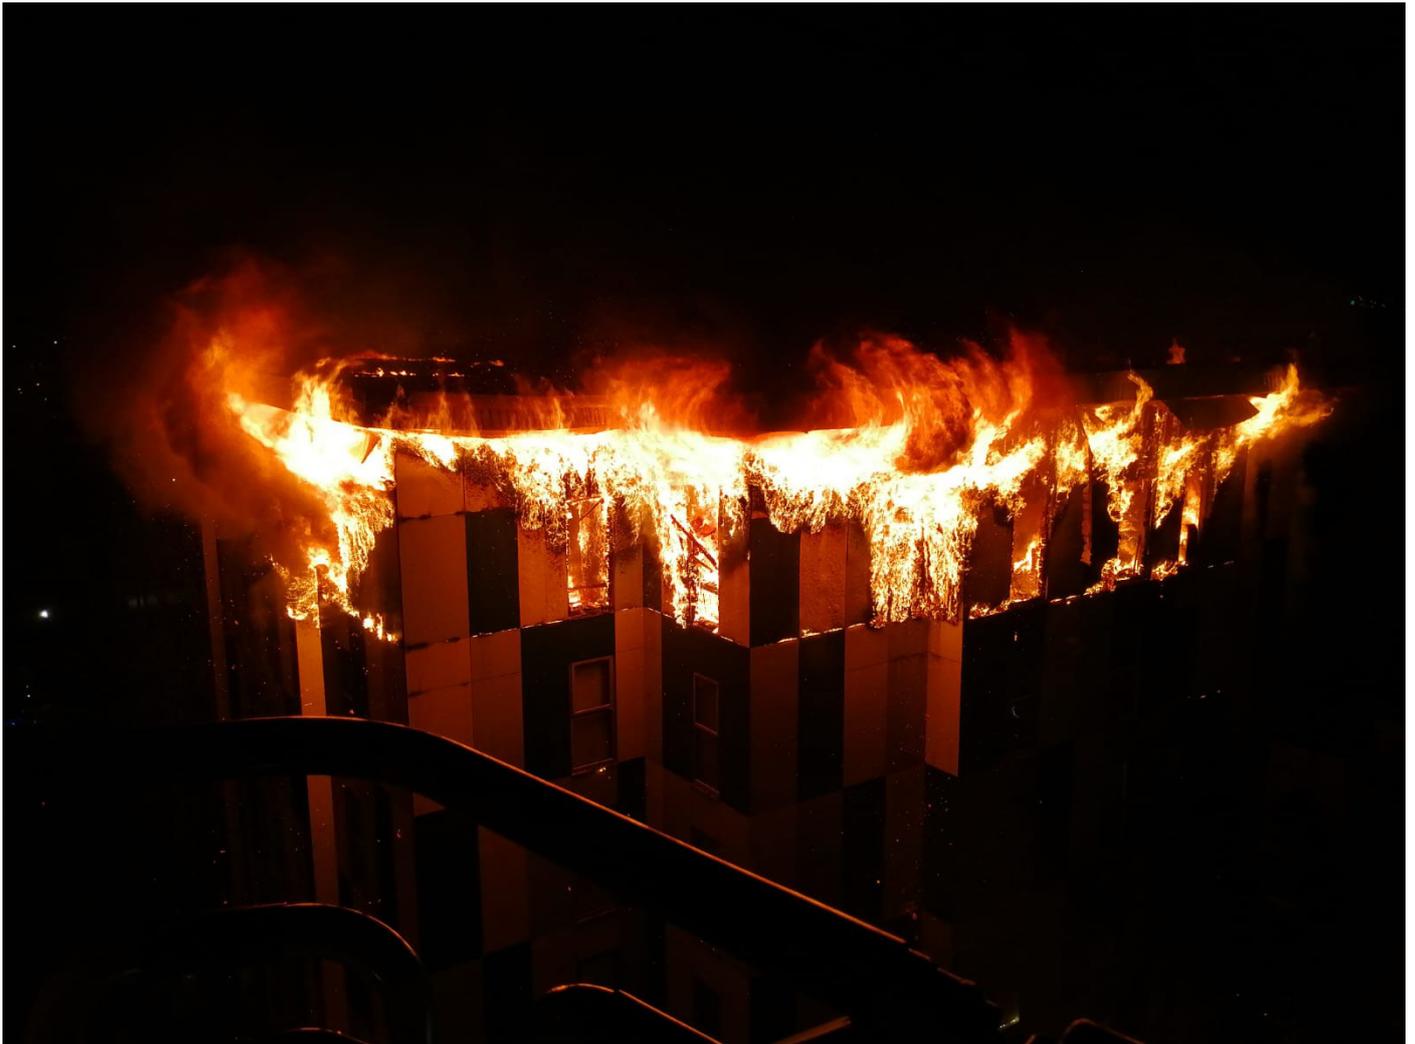
Image 1: The Cube – 15th November 2019

- 4.** A subsequent detailed investigation has determined a discarded cigarette as the most probable cause of fire.
- 5.** Despite life being evidently at risk from the very intense and unpredictable fire, no serious injuries were reported and all 217 residents were accounted for.

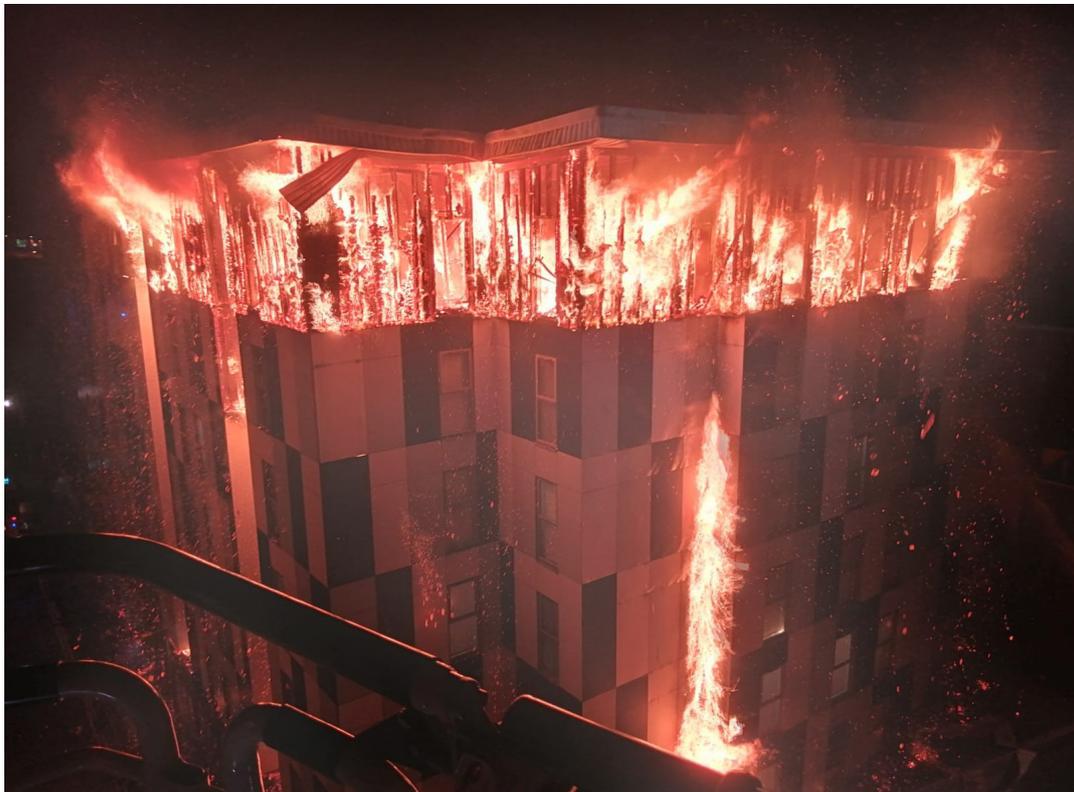
Image 6: The Cube – 15th November 2019

At **22:34** hours the IC sent an informative²¹ message to NWFC stating “fire involving high rise student accommodation, several floors well alight, primary search unable to be completed due to severity of fire, building is six storeys in height approximately 30 metres by 30 metres. Unknown numbers of persons accounted for at this time. BA crews now withdrawn, two Aerials and multiple jets in use in offensive²² mode. RVP now established at junction of Bradshawgate and Trinity Way”. NWFC asked if the type of cladding is known at this time and it is stated this is ‘high pressure laminate’.
